AVALON SUCCESSFULLY AND SAFELY DELIVERS HIGH PROFILE GEOTECHNICAL AND CONSTRUCTION BLASTING PROJECTS.

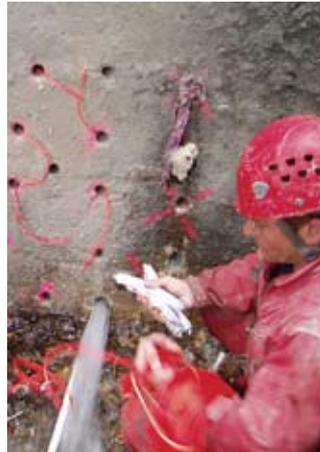
ABOVE LEFT. Setting charges to demolish old dam.

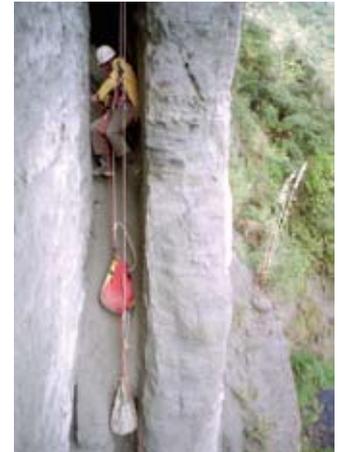
ABOVE RIGHT. Blasting rockfall hazards for Gas Corp, Whitecliffs.
